SERVICE BULLETIN

Ref: SRV - 016- 004

Product: Honey Bee AirFLEX tables model year 2014, 15 and 16

Re: Bearing clamp bolts

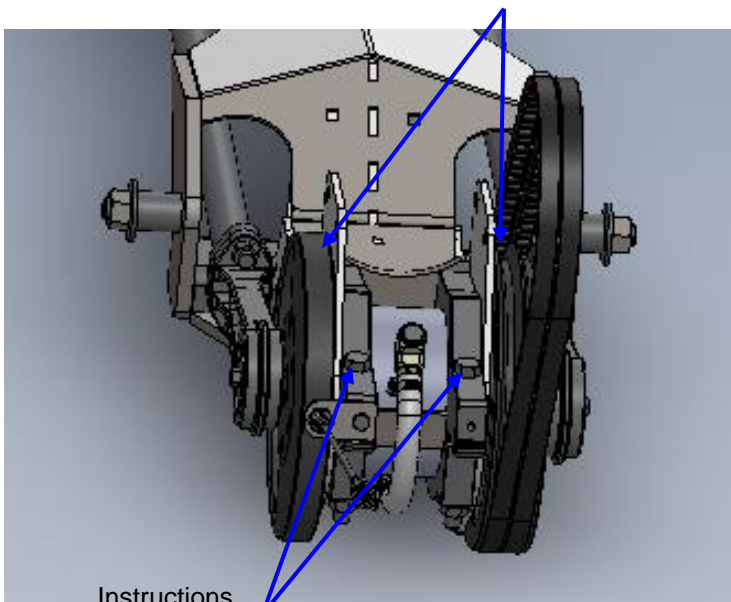
Problem: Std. torque on bearing clamp bolts is inadequate, bearing and flywheel assembly will slide and contact housing. The contact will cause **FIRE**.

Important: After torqueing bolts make certain flywheels are not making contact with any part of the housing as they rotate.

Solution: Remove gr. 5 bolts and reinstall gr. 8 bolts, torque to 120ft.lb. (Note: If gr. 8 bolts are not available torque existing bolt to 120 ft.lb.).

Remove the 2 – ½ x 5 ½” gr. 5 unc. bolts. Replace bolts with 2 – ½ x 5 ½” gr. 8 unc.

Torque bolts to 120 ft.lb.

Note: If gr. 8 bolts are not available torque existing bolt to 120 ft.lb.
