Honey Bee Manufacturing Ltd.

SERVICE BULLETIN

Ref: SRV - 011-007

Re: Proper torque on knife head clamp bolt.

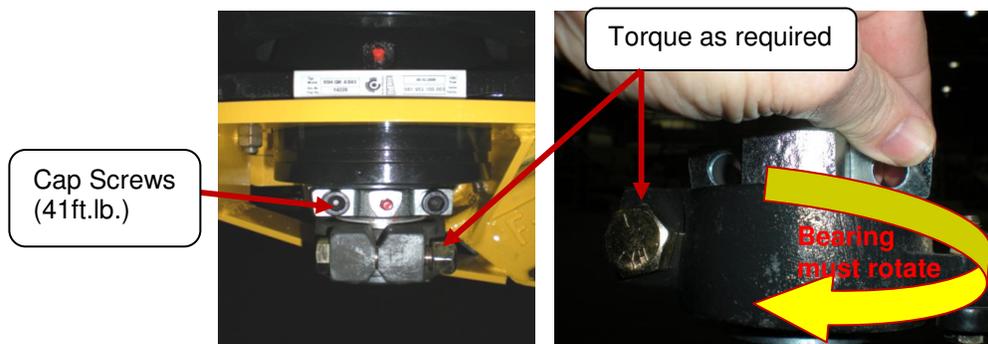
Problem: Improper torque cause premature sleeve wear and bearing failure.

- 1) Remove caps screws holding bearing block in place.
- 2) Retract complete knife approximately a foot or until bearing block and be easily rotated by hand.
- 3) Rotate bearing block, if bearing rotates freely by hand then proper torque has been applied to the knife head.
- 4) If bearing is tight when manually turned, then back off slightly.
- 5) If the knife head can slide up and down easily on the bearing, tighten clamp bolt (over tighten moderately and then loosen off until bearing turns free).
- 6) Reinsert knife and torque cap screws (41ft.lb.)
