SERVICE BULLETIN

Ref: SRV-019-002

Product: 200 Series and SDX AirFlex Headers

Re: Belt Tensioner Information

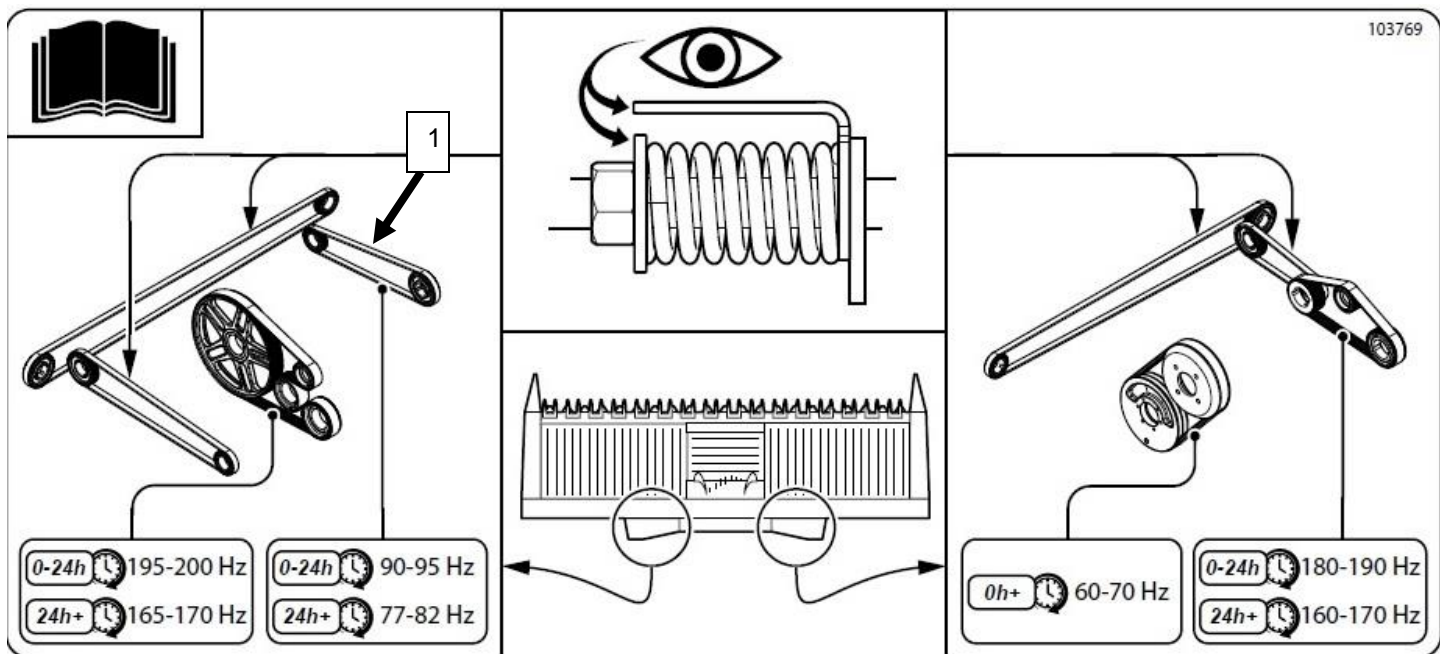
Figure 1

Problem: Failure of the drive belts on the header.

1. We have seen some failures of the drive belts on the AirFlex headers this past season due to improper tension. To help make certain that the belts are tensioned properly a new decal will be added to all headers. This decal shows the proper tension on the belts. (See Figure 1).

- Hold the phone under the long span of the belts with the Fine Tuner app turned on. (Figure 2)
- Tap the belt with a large wrench 3 or 4 times.
- Read the Hertz on the phone (example in Figure 3)
- Adjust the belt to the proper tension listed on the decal.

Most of the belts require a new and used setting.

- A used belt should run 24 hours before it be classified as a used belt.
- During PDI all belts should be adjusted to the "New" setting.
- A new header should have ALL of the belts adjusted after 24 hours of operation. This includes the belts that use a spring gauge for adjustment.

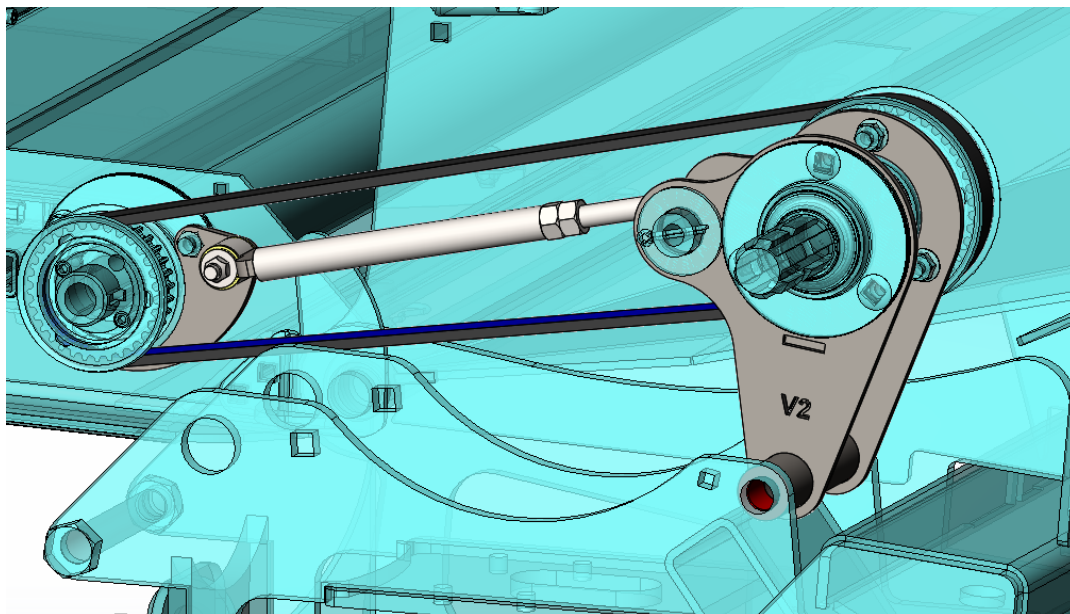
Figure 4

2. The Feeder Deck drive belt tension system was also changed for the Model Year 2019 headers. On past years the tension system was a spring system. This spring system would allow the belt to jump if the combine reverse was too harsh or if the system was “rocked back and forth”
 - To resolve this issue in 2019 the drive belt for the feeder deck (item 1 Figure 1) no longer has a spring on the tensions system.
 - This belt must be adjusted with the fine tuner app. (Figure 4)
 - For units Model year 2017 and 2018 that have an issue with the belt failure due to the combine there is a kit to convert the spring tension system to the direct tension system. The contents for the kit are listed in Figure 5.
 - **Note: This kit will only work on Model Year 2017 and 2018 Headers. This kit cannot be installed on any MY 17 that had the subframe converted to a non-suspend frame.**

Upgrade tension kit is only needed on combines that have issues with the belt during reversing the feeder house.
