## SERVICE BULLETIN

Ref: SRV-021-001

Product: AirFlex, SDX and RDX

Re: Center Draper Drive Chain Tension

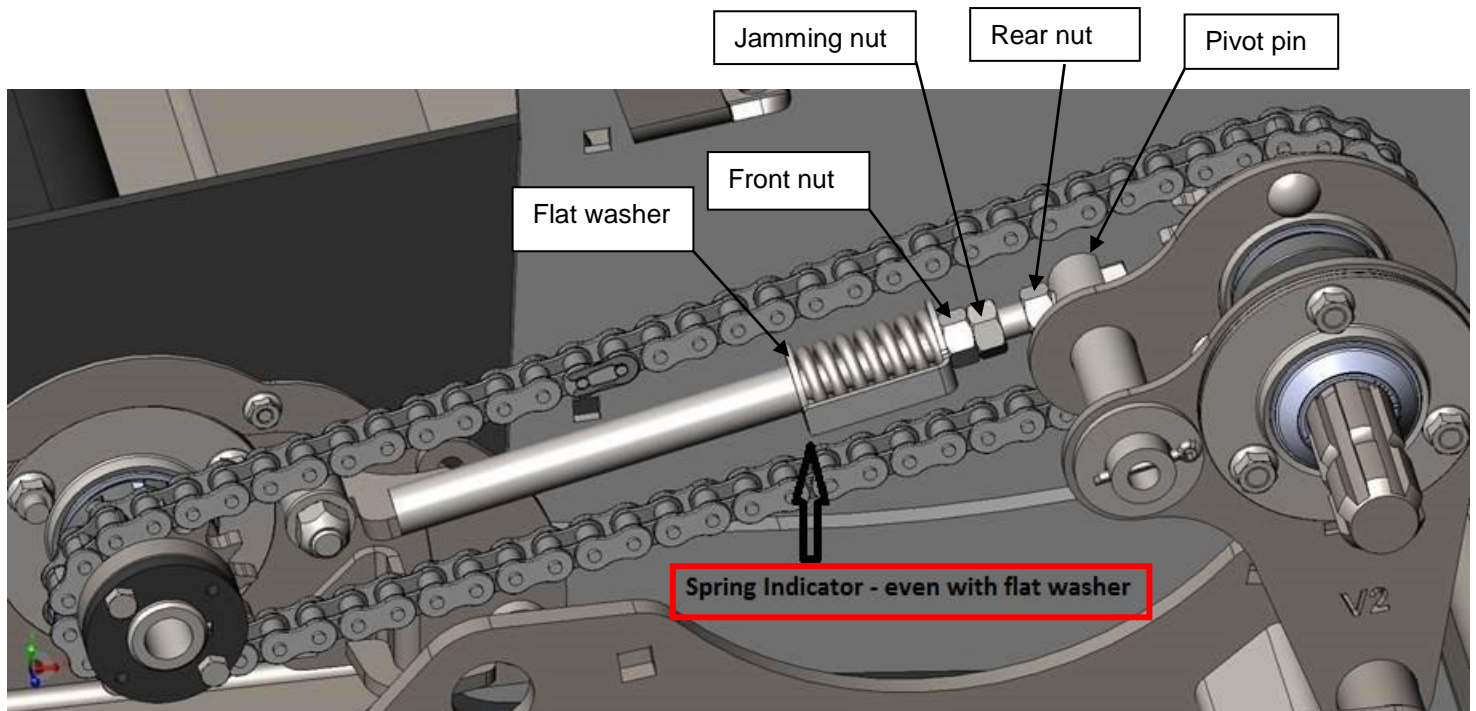
Figure 1

**Problem:** The Center Deck drive chain does not stay at the correct tension. If the nuts are not in the correct position the spring tension can change.

**Solution:** If possible, use the combine to lift the header off the ground, and retract the tilt cylinder all the way. Ensure the rear nut of the tension rod is tight against the pivot pin, keeping the tension rod (bolt) in position. The tension on the drive chain is correct when the spring indicator is even with the flat washer. The adjustment is obtained by tightening the front nut. Once the proper tension is achieved the second nut should be jammed against the front nut holding the spring position. See call outs in Figure 1.
