Honey Bee Manufacturing Ltd.

## SERVICE BULLETIN

**SVR 09-004**

**Product:** Grain Belt Header, Wide Strut Swather Table and Grain Belt Plus.

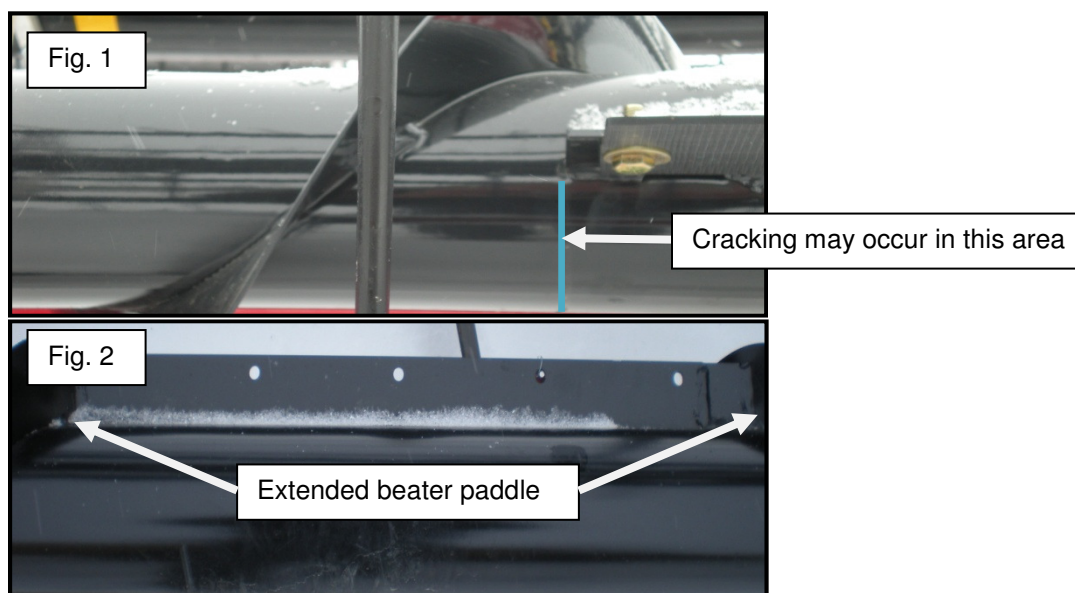
**Problem:** It has been brought to our attention that a stress crack may occur in the cross auger tubing, originating in the weld at the end of the beater paddle (*as per Fig. 1*). The beater paddle is located on the center section of the three piece cross auger. If operating continues once the crack has developed, the result will be complete auger failure.

**Solution:** Examine existing product, if damage is observed remove center auger and replace with correctly manufactured part, on which beater extends from LH flighting to RH flighting (Fig. 2).
