SERVICE BULLETIN

SRV 09-009

Product: Grain Belt Plus 2009.

Re: Roller arm clamp replacement.

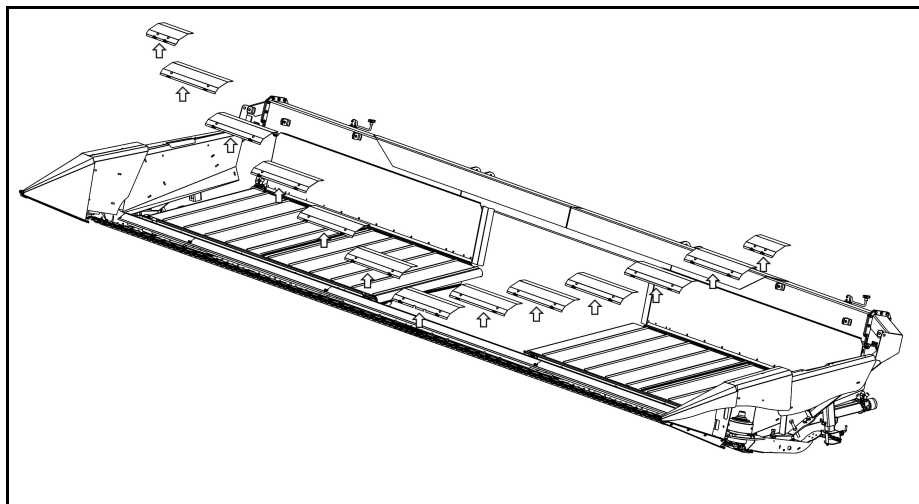
2. Release air from the fittings located next to the air gauges between the sub frame and the main header frame until the cutter bar reaches its lowest point of travel.
3. Starting at the outside ends and working your way to the center of the table, remove all of the feather plates from the cutter bar and expose the sensor tube and the sensor roller arm clamps.

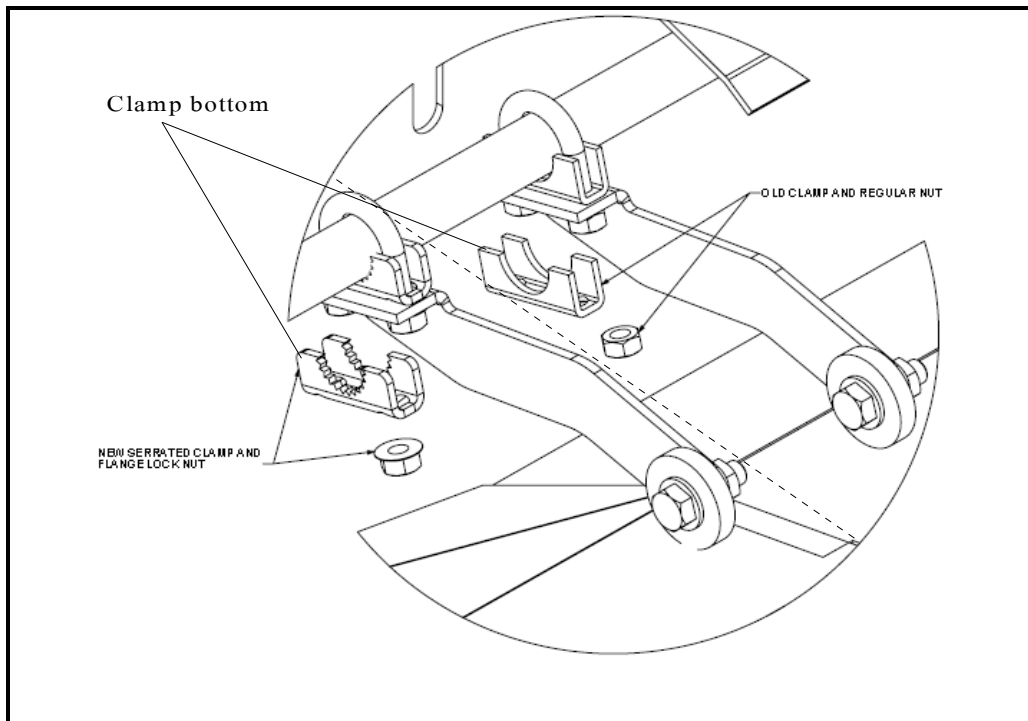
Problem: Cutter bar header height roller arm clamps will not stay tight.

4. Remove and discard existing roller arm U clamp bottom and the UNC retaining nuts.

5. Replace with serrated U clamp bottom and flange nuts, as shown above.

NOTE Remove and replace one clamp at a time to make certain return spring retains the required tension (refer to on line header height supplement for spring tension information and header height calibration).
