## SERVICE INFORMATION

**Ref:** SRV - 013-005

**Product:** UII REEL WS and GRAIN BELT

**Re:** UII REEL DRIVE COUPLER

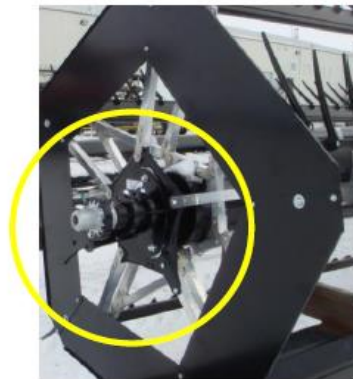
**BEFORE**

**Problem:** Drive coupler failure.

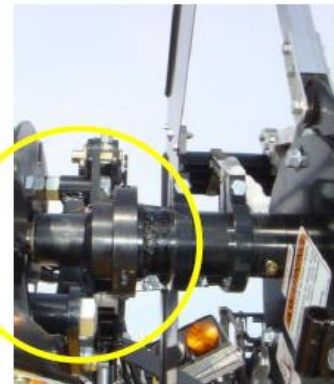
**AFTER**

**#94656**

**Solution:** Replace with new style reel drive coupler, roll pin and collar.

**Ordering Information:** 1 - 94656 - COUPLER KIT-REEL DRIVE-UII

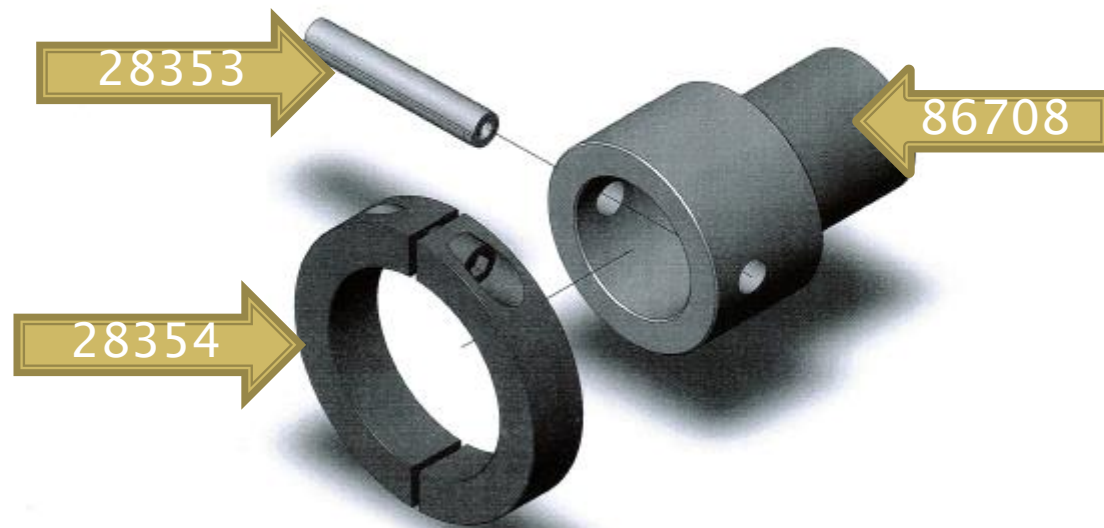
# REPLACING DRIVE COUPLER ASSY.

- ▶ PARTS REQUIRED: KIT # 94656
- ▶ REMOVE DRIVE MOTOR.

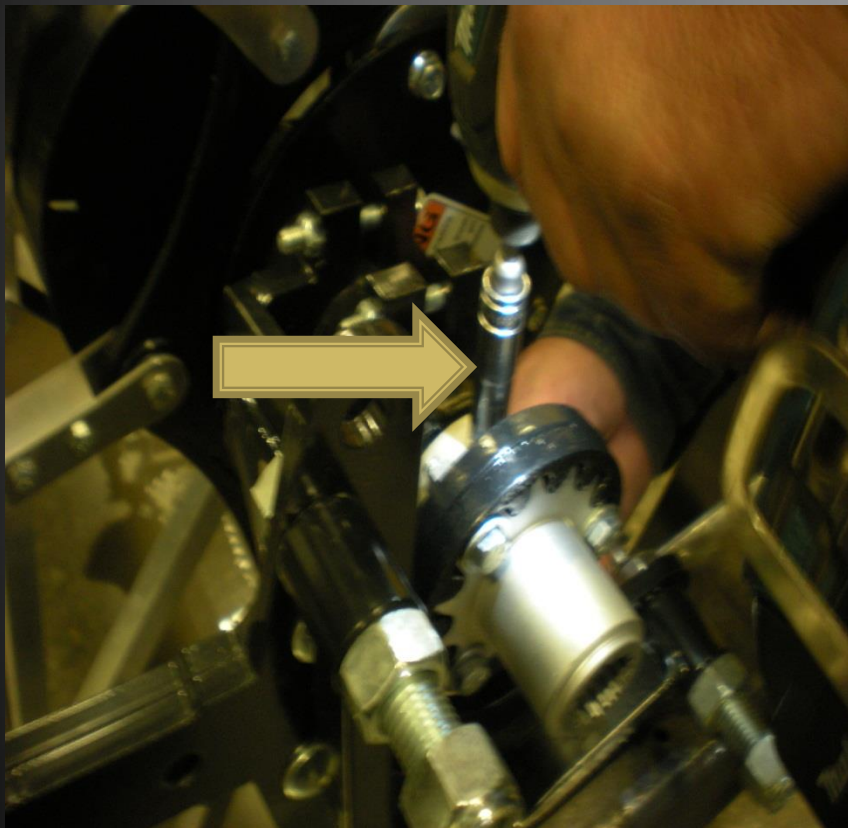
**REMOVE BOLT ON EXISTING COUPLER  
ASSY.**

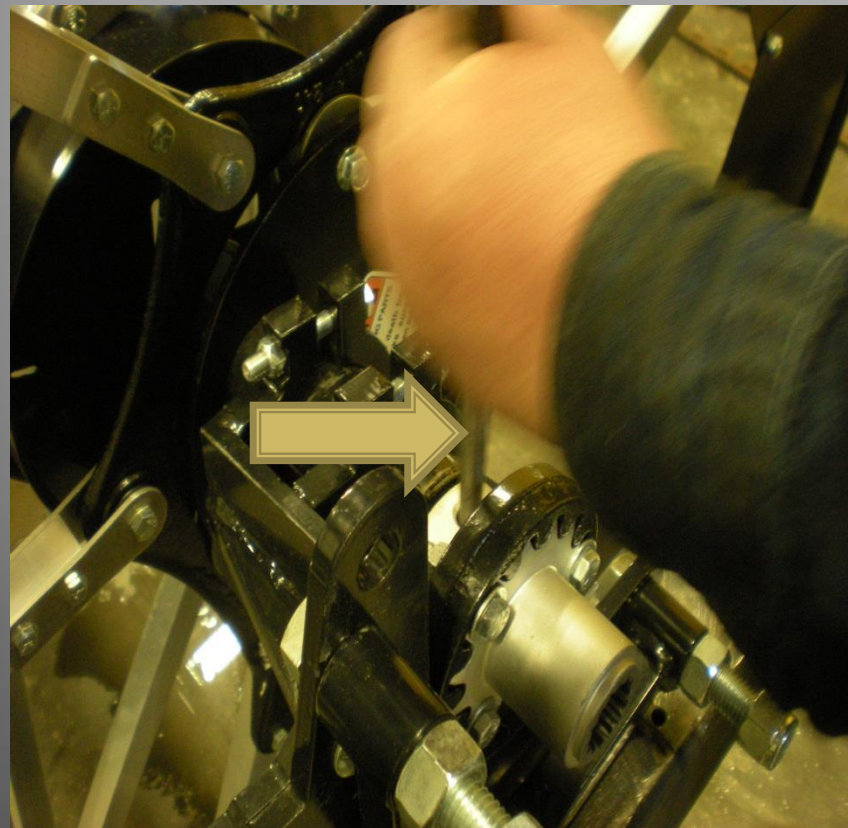
**DRIVE ROLL PIN OUT AND REMOVE COUPLER FROM  
SHAFT.**

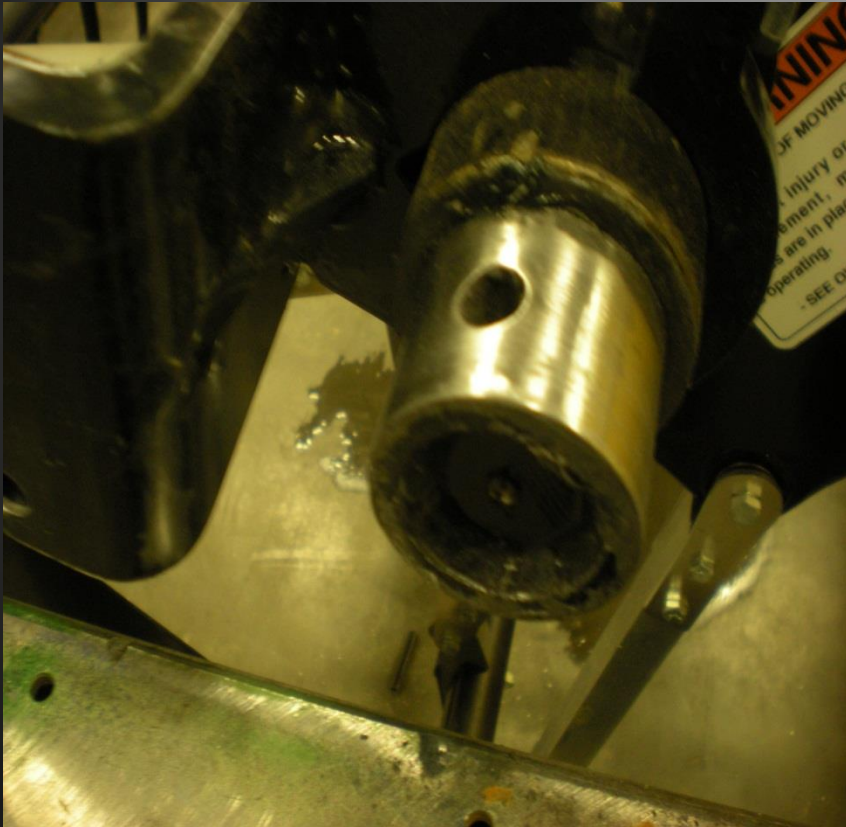
**CLEAN SHAFT SURFACE FOR NEW COUPLER INSTALLATION.**

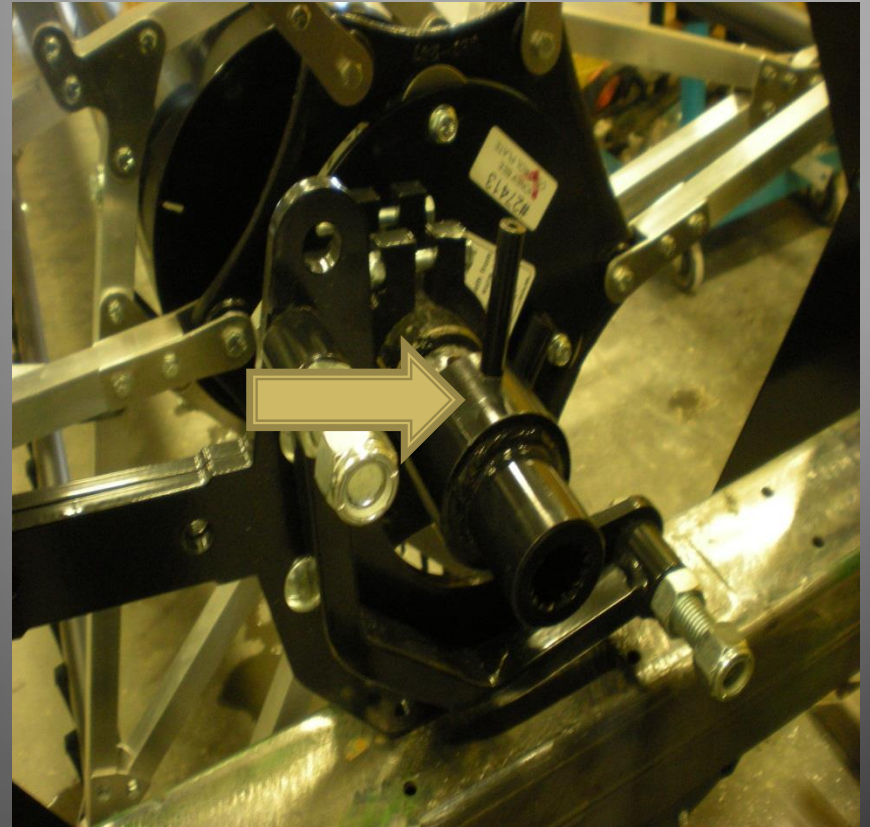
**SLIDE NEW COUPLER ASSY. ON TO REEL SHAFT**

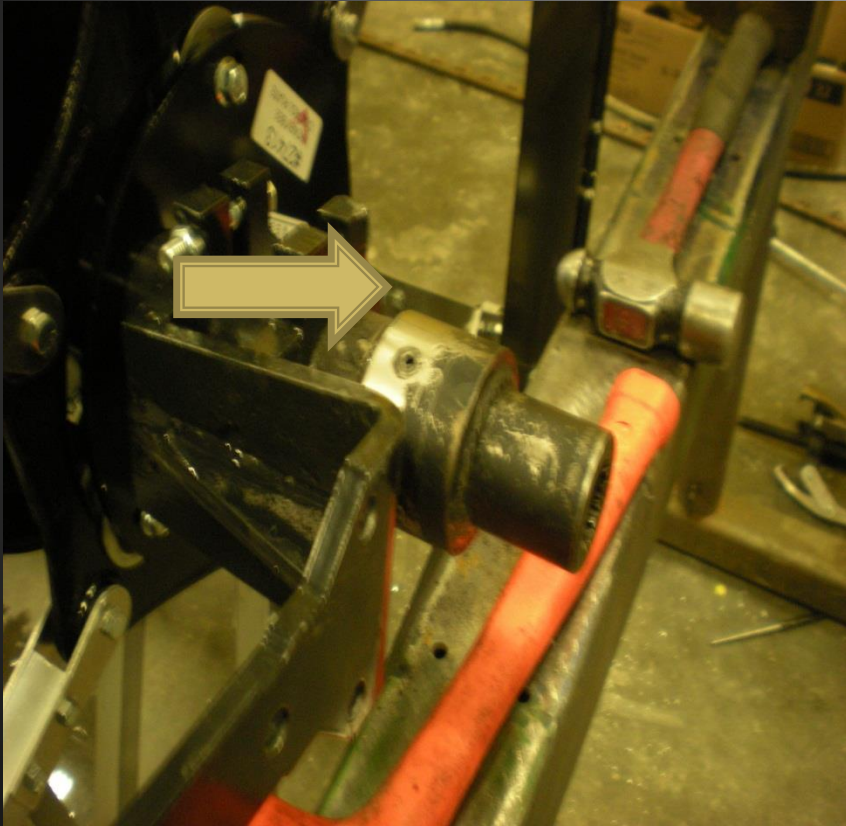
DRIVE SPRING PIN THROUGH COUPLER AND REEL SHAFT

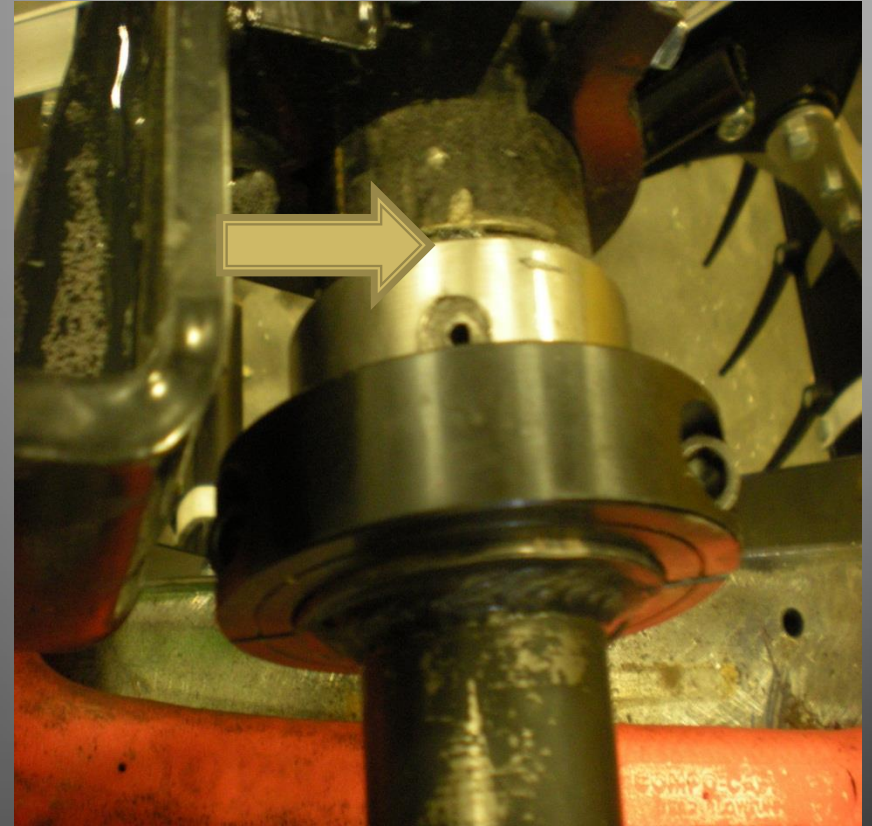
SLIDE COUPLER SLEEVE OVER COUPLER AND SPRING PIN.

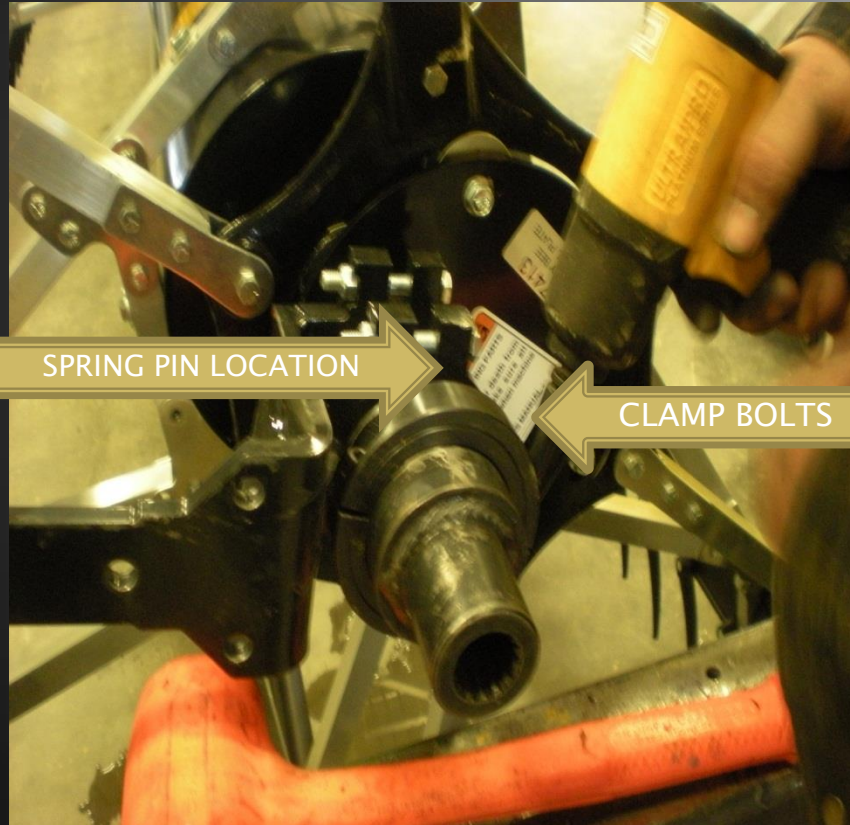
SPRING PIN LOCATION

CLAMP BOLTS

MAKE CERTAIN SPRING PIN IS CENTERED IN COUPLER SLEEVE PRIOR TO TIGHTENING CLAMP CAP SCREWS.

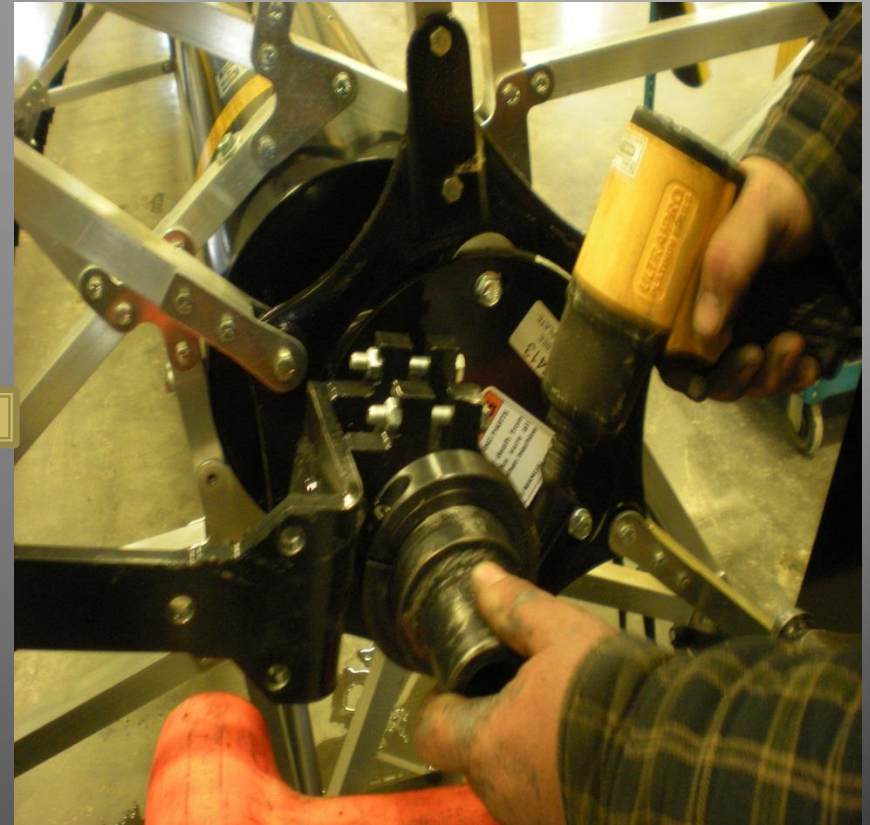
TIGHTEN CAP SCREWS. REPLACE DRIVE MOTOR
