SERVICE BULLETIN

Ref: SRV-018-005

Product: AirFlex 200 Series and SDX Series

Problem: The telescoping PTO shafts that attach to the combine may bind and cause bearing failure and frame cracking. This has been caused by lubrication on the PTO shafts, with heads using the Cerjack PTO shaft.

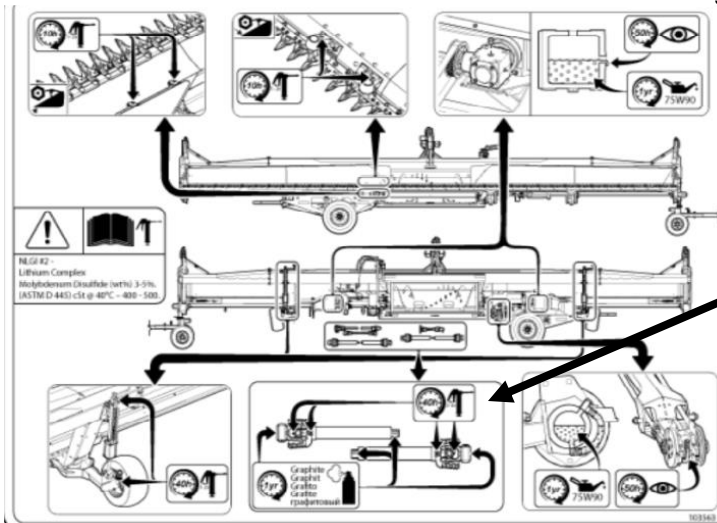
The new lubrication decal has that recommendation. See Figure 1 and 2.

In order to eliminate the binding, it is recommended to use a spray graphite lubricant on the male and female portion of the shaft.

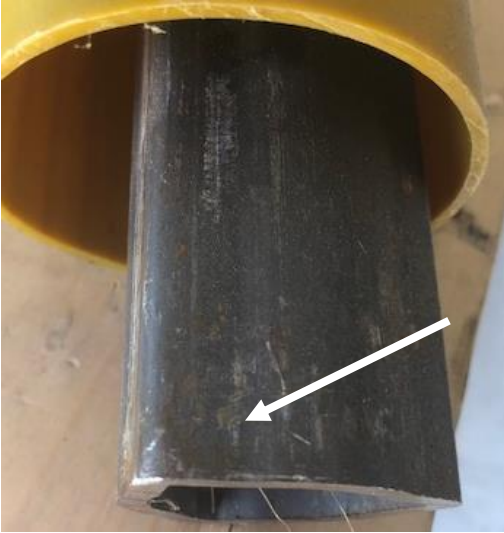
Figure 3

- To lubricate the female section of the shaft, use a parts cleaner to make sure the inside tube of the section is clean. Then spray the graphite inside the tube. Figure 3.
- To lubricate the Male section of the PTO shaft. Remove the 5 screws on the underside for the bell shield, Figure 4. Remove the shield over the male part of the shaft, this will expose the male drive shaft. Figure 5
- Clean the grease and any rust off the male shaft. Spray graphite lubrication on the entire length of the male shaft.
- Lubricate both the PTO shaft splines and the splines on the jackshaft of the combine with the graphite. Make certain the lugs that retain the PTO to the jackshaft on the combine are also lubricated. Figure 6

If you are seeing any grease on either the male or female portion of the shaft, the grease needs to be cleaned off before the graphite is applied. This graphite needs to be applied once a year at the beginning of the season. The graphite can be any type of spray. Anything with a grease base will collect dirt and cause binding.
