SERVICE BULLETIN

SRV 09-009

Product: Grain Belt Plus 2009.

Re: Roller arm clamp replacement.

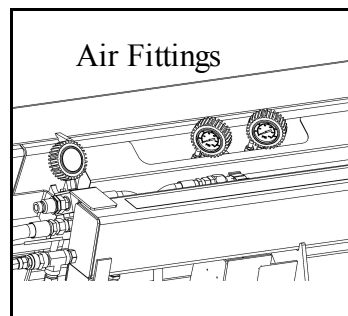
Problem: Cutter bar header height roller arm clamps will not stay tight.

2. Release air from the fittings located next to the air gauges between the sub frame and the main header frame until the cutter bar reaches its lowest point of travel.
3. Starting at the outside ends and working your way to the center of the table, remove all of the feather plates from the cutter bar and expose the sensor tube and the sensor roller arm clamps.

Solution: Replace U clamp bottom and existing UNC nuts.
