## SERVICE BULLETIN

**Ref: SRV-17-002**

**Product: AirFlex**

**Re: Divider Lock Assembly**

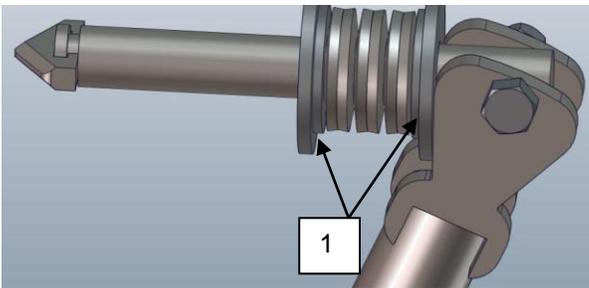
**Problem:** The dividers will fall off the end sheet or will become loose causing calibration issues by allowing the divider to move with the sensor.

The two flat washers on the end of the latch, item 1 Figure 1 Part number 19940, are removed. Install two Belleville washers, Part number 26571, in their place as shown in Figure 2. The washers should be installed in pairs with the cupped side toward each other as shown.

**Solution:** The spring washers on the over center latch will become loose. The divider will not be held to the end sheet and can cause the latch to turn and allow the divider to fall off. In order to resolve the issue the spring washer arrangement has been changed. The number of the Belleville washers has been increased. This will increase the tension on the latch and hold the divider to the end sheet.
