SERVICE BULLETIN

SV 09- 002

Re: Reel arm lock bar.

Reel Arm Lock Bar Replacement Instructions

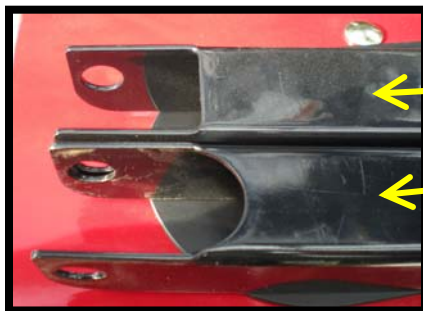
Problem: Due to improperly manufactured parts the reel arm lock bar cannot be placed in lock position.

G67229 Incorrect

P81619 Correct

Notice that the correct part has been cut with a radius to clear the cylinder yoke.

Solution: Replace incorrect part with correct part as per photo below.

Parts Required: **P81619** - Reel Lift lock bar - Qty 2.
 70050 - Decal - Warning cyl. Lock - Qty 2.

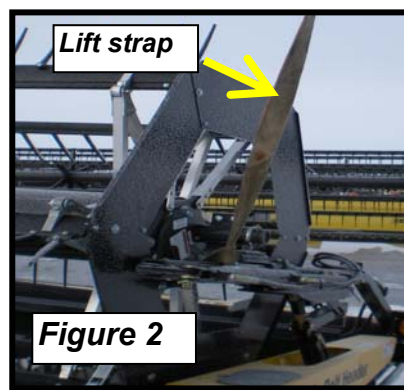
Figure 1

Step 1: Using proper lifting device and lift strap, lift reel and remove weight from reel arm.

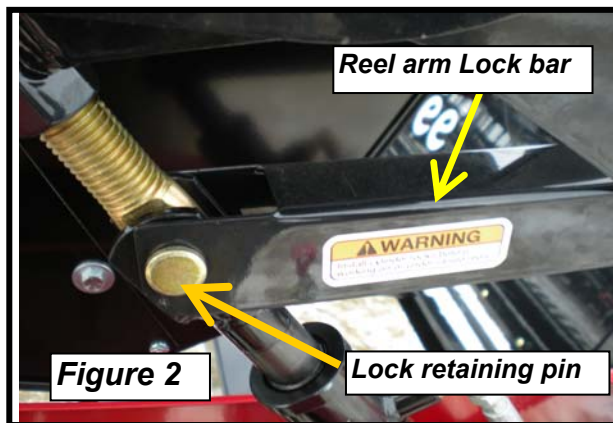
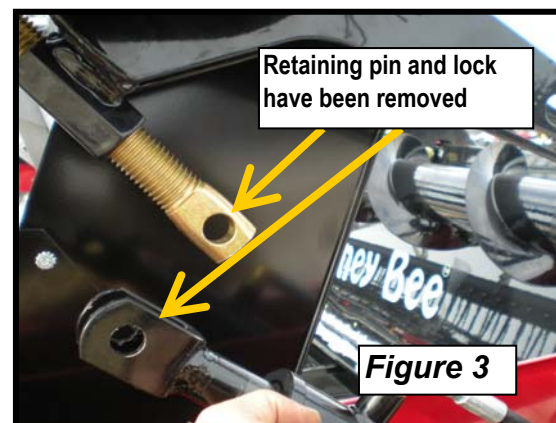
Figure 2 & 3

Step 2: Remove reel lock retaining pin.

Step 3: Install replacement reel arm lock bar and replace pin, both right and left side.
