SERVICE BULLETIN

SVR 09-003

Product: 2009 WS Swather & Grain Belt Headers

Re: Improperly located bolt on <u>2009 WS & Grain Belt Headers</u> shipped from factory prior to Jan. 29, 2009

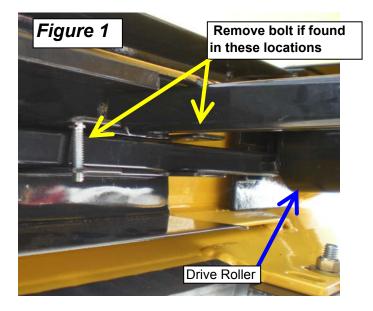
Problem: A bolt may have been incorrectly attached to either right or left deck, near the drive rolller end.

Solution: Check tables and remove bolt if found, **bolt must be removed to prevent draper damage.** <u>Figure 1</u>
